# Drive System

Shougang Hierro Perú SAA (SHP)  
Mina Marcona, Nazca-Ica, Peru  
**GSSF 2000×47.7 Sacrificial Belt**

# First Backstop Failure

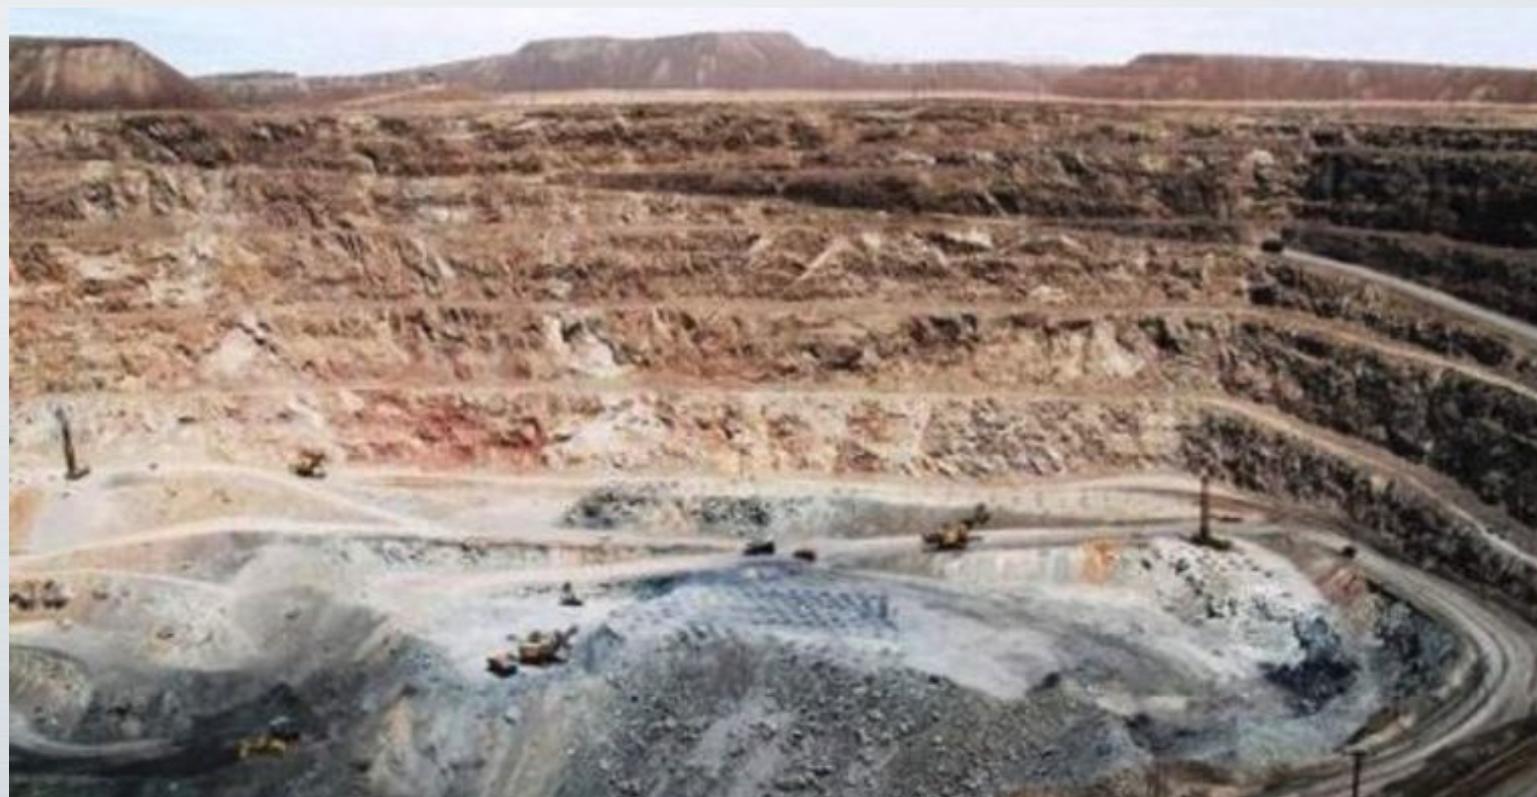
# Semi-mobile Preliminary Crusher

The ore in the new Mina area is taken to the preliminary semi-mobile crushing plant, with a capacity of 2,500 t/h. At the top of the plant is a hopper where dump trucks unload, which drops the ore into the cone crusher.

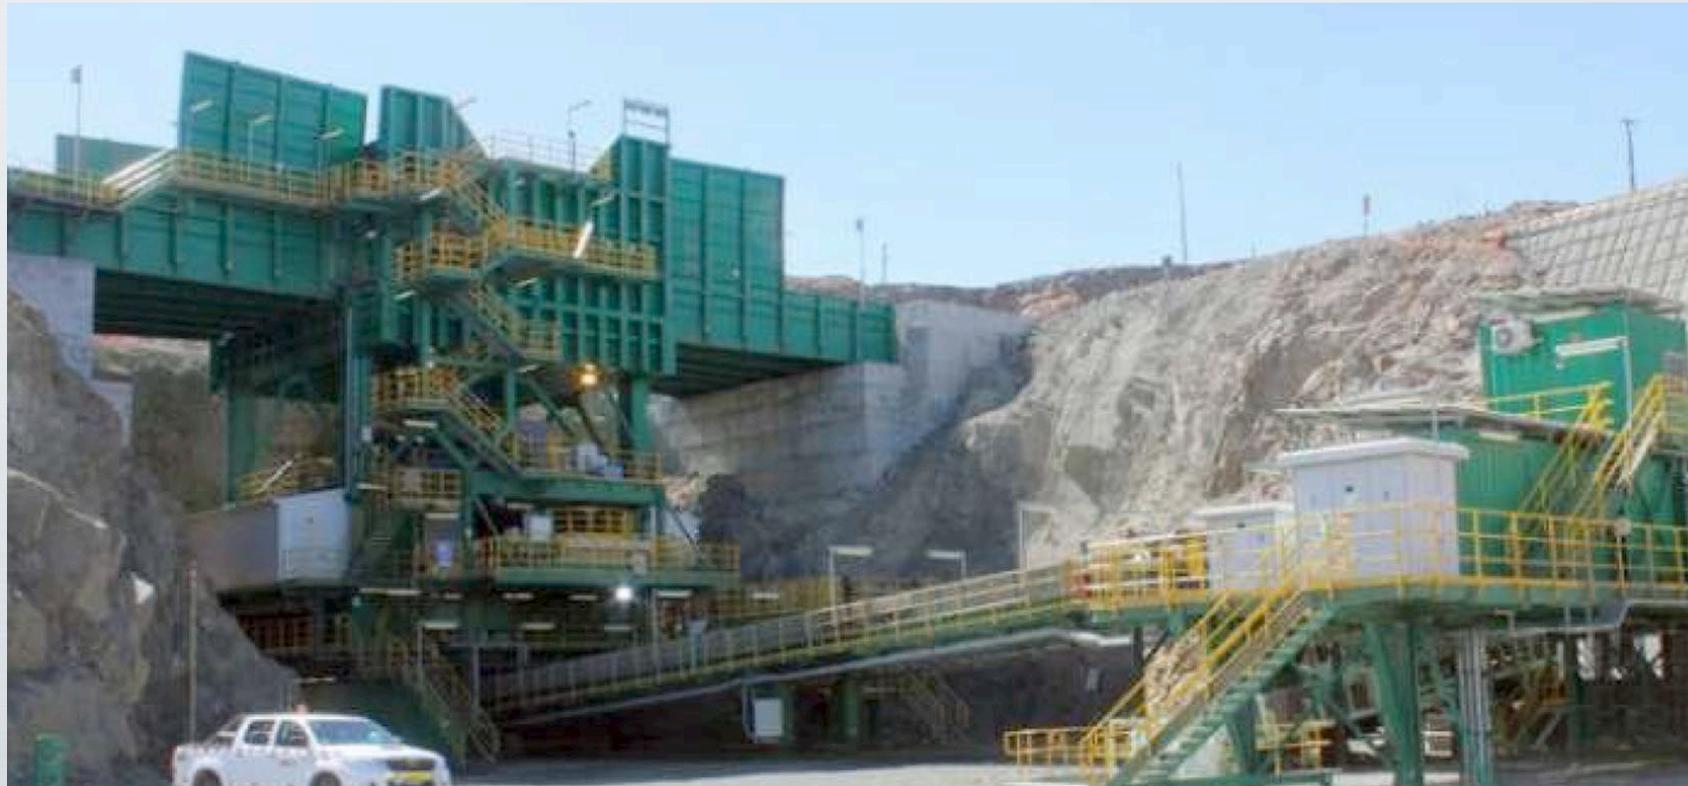
# Discharge Belt GSSF 2000×47.7

It is a strip of 2000 mm wide and 47.7 m long. This girdle receives crushed ore vertically and unloads it with horizontal velocity in other longer belts, protecting them, like a sacrificial belt, from intense wear.

This belt can work at a mass flow of up to 3050 t/h but currently operates at 2,800 t/h due to limitations of the following belts. The belt transports high-grade and low-grade ore at the same mass flow, regulating the speed.

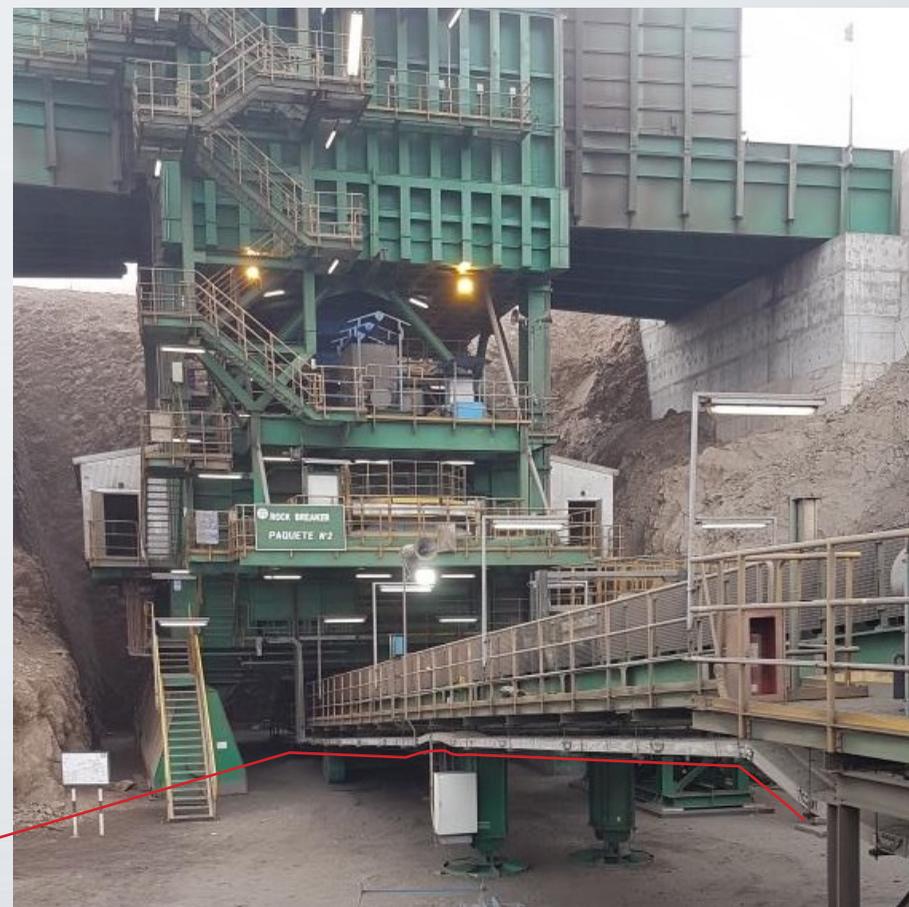
# The Sacrificial Belt Drive (2/2)

In this plan view of the drive, the rigid slow coupling can be seen embedded in the drive pulley shaft of the belt. In addition, on the same side of the reducer, the parking brake with which it is equipped can be seen.

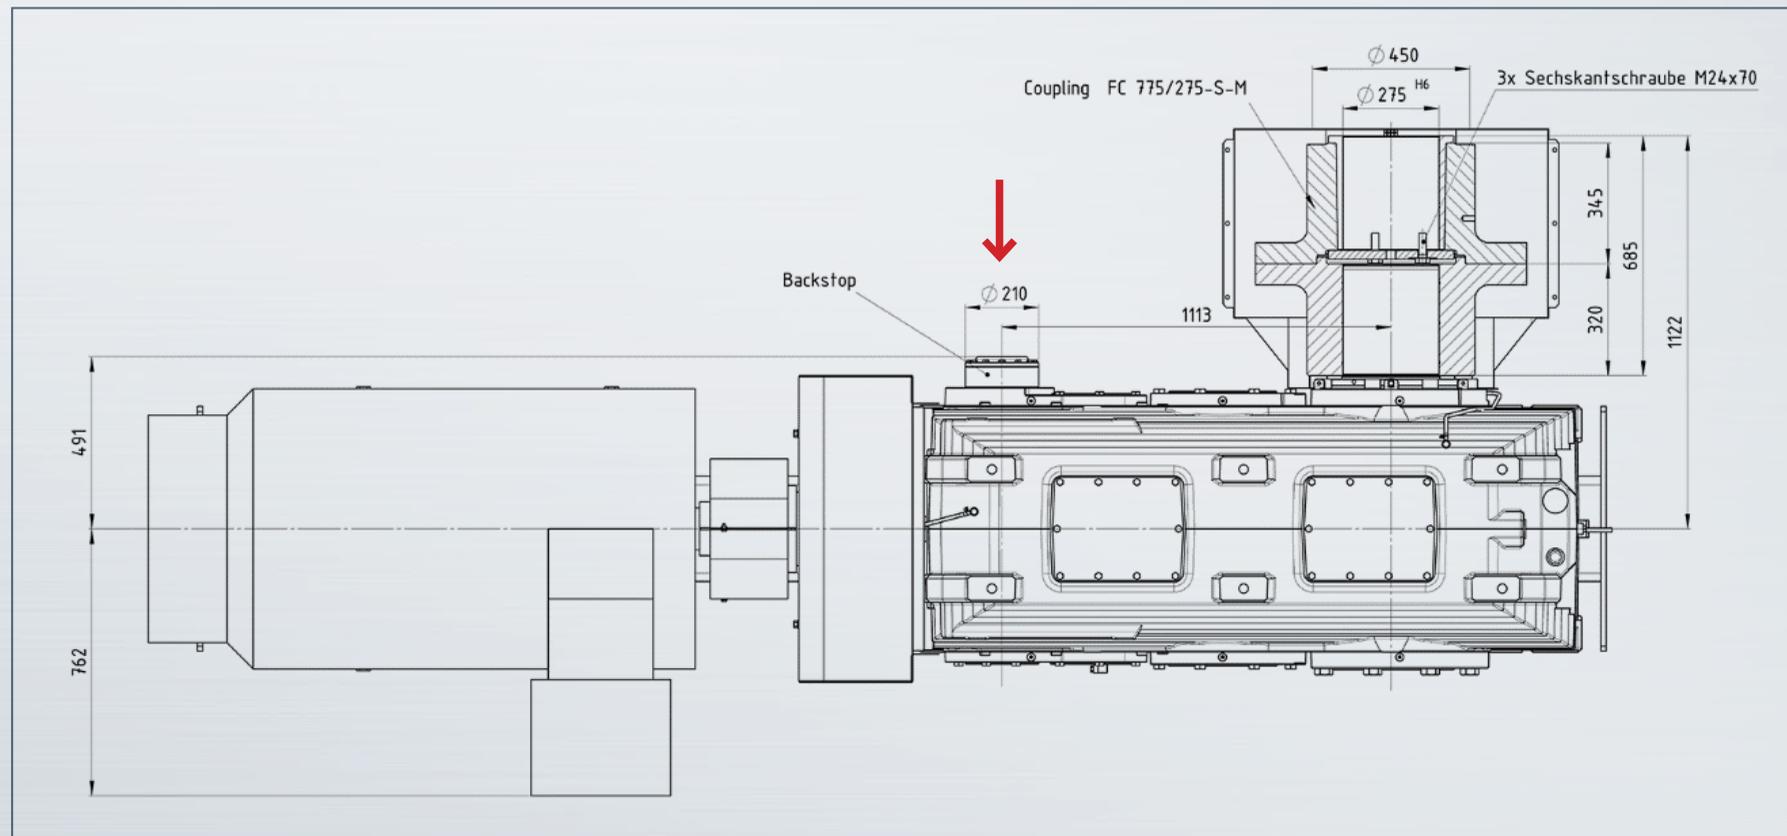
The stationary brake installed on the original drive is intended to prevent the sacrificial belt from going back one time that the motor has been un-energized.

This stationary brake, chosen by the girder manufacturer, is of the type known as backstop.

This brake, despite its good quality, failed catastrophically shortly after the start-up of the sacrificial belt, as seen in the attached image.

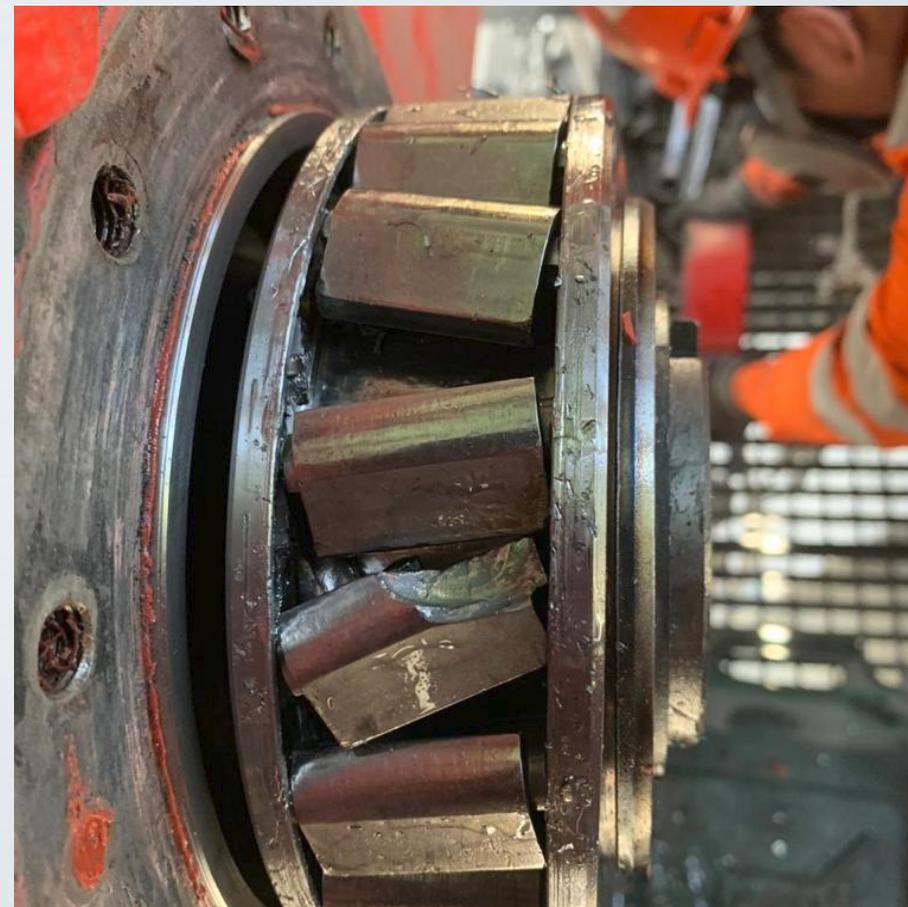
# New Gearbox and New Brake (1/2)

Failure of the backstop brake of the original drive damaged gearbox gears. SHP, therefore, decided to replace it with a new gearbox from MGS, supplied by Atlantic Bearing Services (ABS), equipped with a more robust backstop brake.

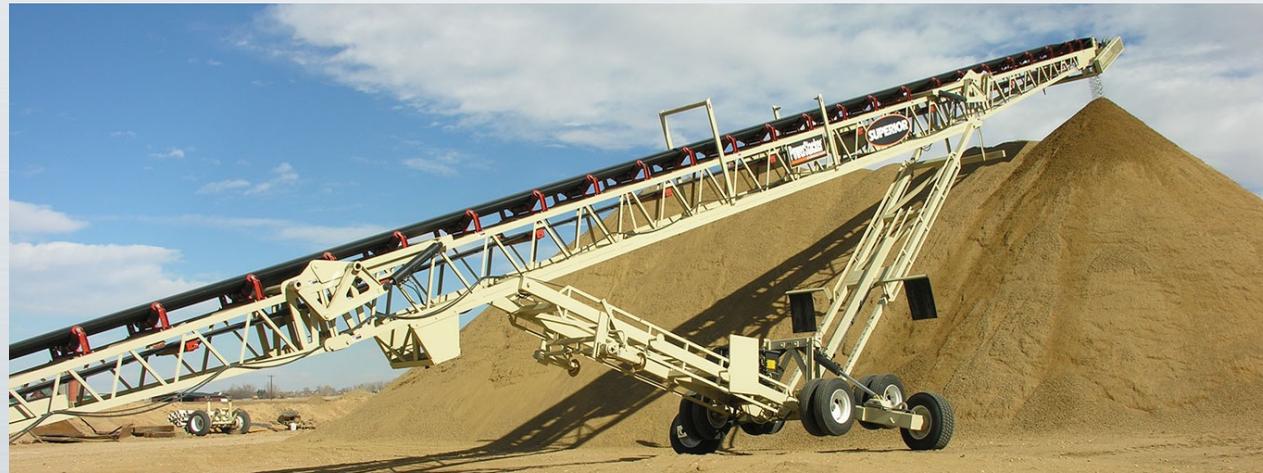
## 5. The Backstop Brake (1/7)

The backstop brake installed on the belt conveyor drive is intended to prevent the loaded belt from moving backwards once the motor has been un-energized.

Many industrial belt conveyors have drives that work in one or two quadrants.

In the first case, the drive can only drive the belt forward. In the second case, the drive can also dissipatedly brake the belt in its forward movement.

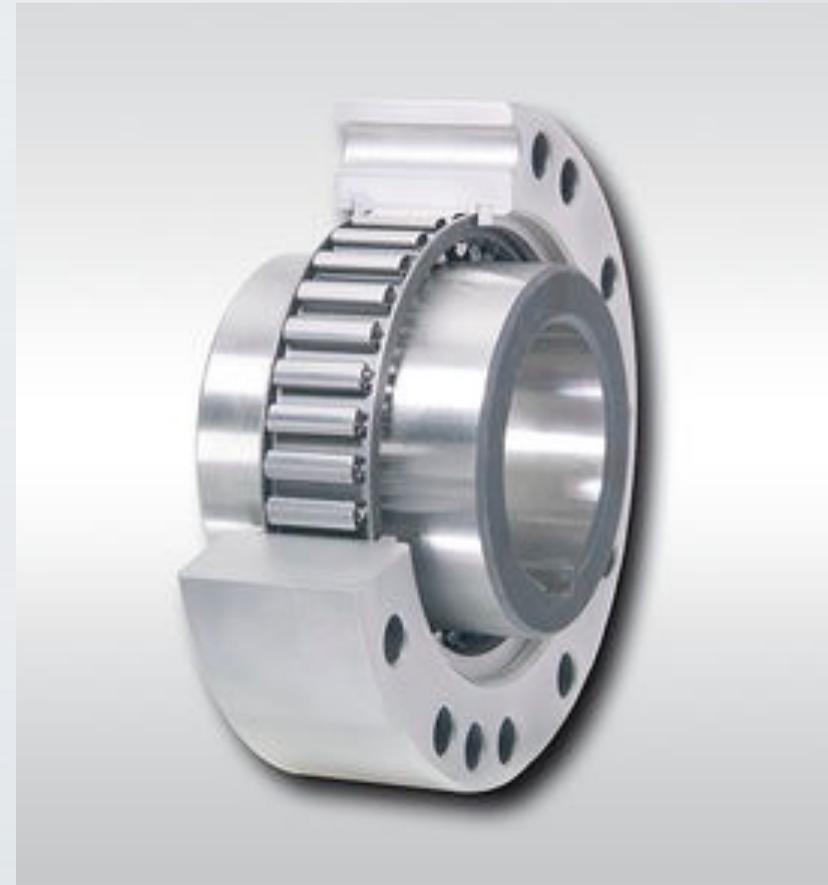
## 5. The Backstop Brake (2/7)

Conveyors with drives operating in one or two quadrants can use backstops as parking brakes.

The drive cannot drive the belt backwards. Once the band stops in its movement and just begins to recoil, this brake blocks it in a turn of no more than 3°.

If the backstop brake is placed on a high-speed shaft of the drive, the stop of the band is instantaneous.

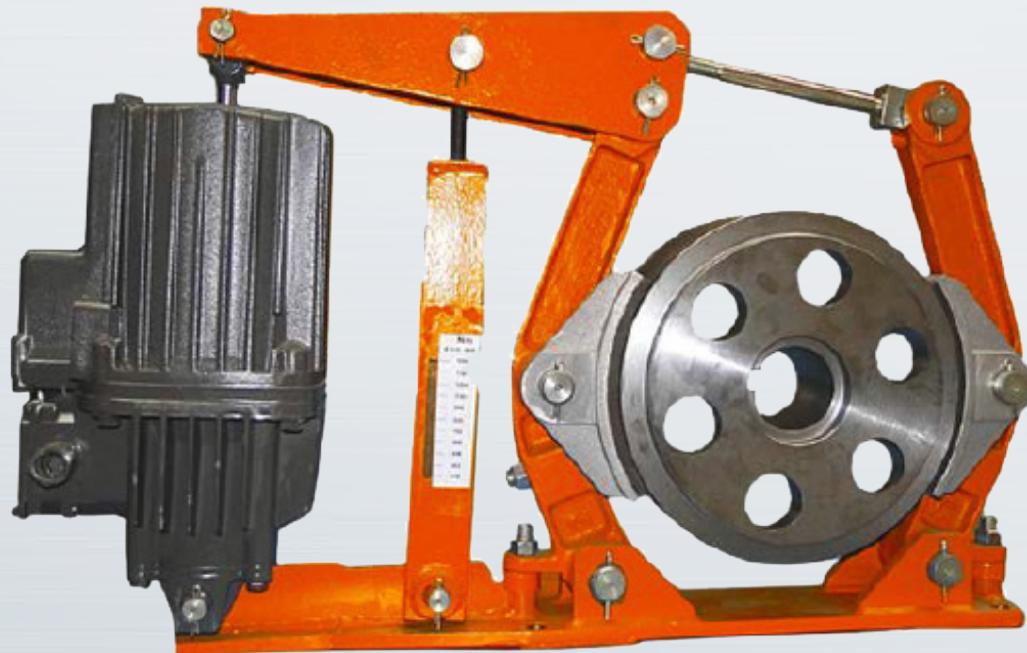
## 5. The Backstop Brake <sup>(6/7)</sup>

That requirement is fulfilled by the friction brakes, which allow a healthy slide, without predetermined limits, before stopping.

An electro-hydraulically controlled friction pad brake suitable for this application is shown in the illustration.

This type of brake can be installed both on the motor shaft and on the drive pulley shaft. In this case, placement on the motor shaft places the brake right next to the motor, whose inertia is several times that of the rest of the conveyor and its load.

That way, most of the braking torque will be applied directly to the motor, and much less through the reducer to the conveyor and its load.
